Component replacement labor

For crushing equipment

Case studies - Crushing

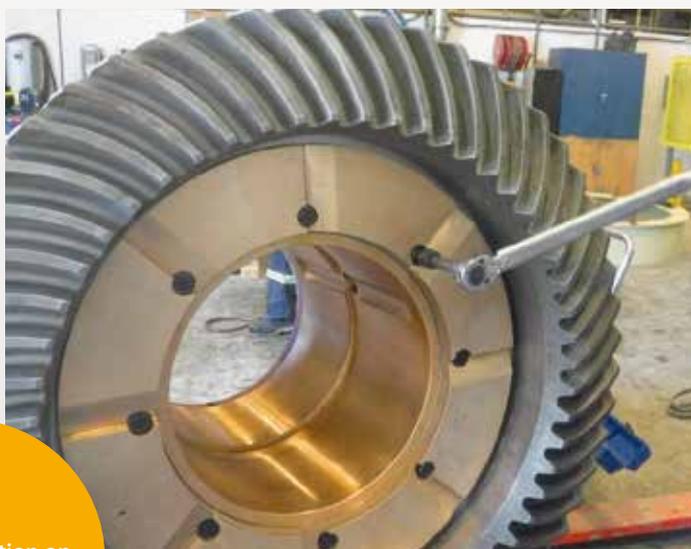
Complete countershaft box reassembly

A gold miner in central Canada ran into issues with a broken countershaft box on their HP 700 Metso crusher. A temporary fix was put in place until new replacement parts could be delivered to the site. The client decided against doing the repair themselves as it involved using the old spare shaft with a new countershaft box and a new pinion. Tolerances needed to be within a tight range to ensure that the crusher didn't experience excess vibrations or wear due to misaligned gear and pinion.

Overall the repair took 3 days to rebuild the countershaft assembly and reinstall it into the HP crusher, while respecting the tight tolerances required. The Metso Field Service rep identified several potential future issues and made recommendations for start-up and running under load. The client was able to put the crusher back into operation successfully.

First steps in the service work involved preassembling the new countershaft box with the customer supplied shaft and new bushing, oil flinger, cover and seal kit. The new pinion was also installed and needed to be pre heated and shrunk onto the shaft to ensure a tight fit. The older countershaft assembly was then removed from the crusher and the new assembly installed. The end float and backlash root clearance were all verified and found to be within acceptable range.
